PHOTOGRAMMETRY-DRIVEN HBIM: Improving Accuracy and Efficient Integration in Construction and Heritage Documentation - A Study on Data Accuracy, Usability, and Workflow Optimization

- ❖ Pilot Case Study – Al-Takiyya Al-Rifa'ia Al-Ikhlasia, Al-Bayyada, Aleppo, Syria
- ❖ Main Case Study – Jami' Al-Tunbugha, Sahet Al-Melh, Aleppo, Syria

Thesis Submitted for the Degree of Master of
Qualification and Specialization in Building
Information Modeling and Management
(BIMM)

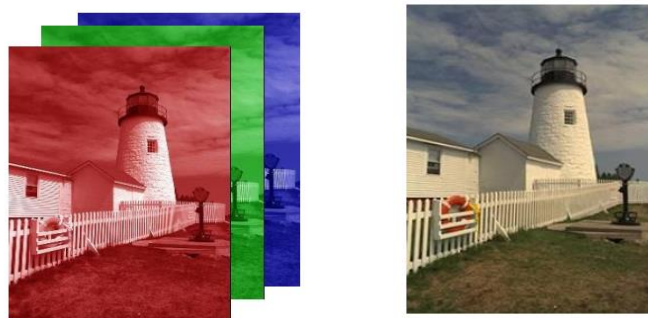
Figure 11: RGB Image

- C. Color Images (RGB Images):** Composed of three channels—Red, Green, and Blue. Each channel is represented as a matrix with values ranging from 0 to 255. A pixel's final color is formed by combining the three components: (R: 0–255, G: 0–255, B: 0–255).

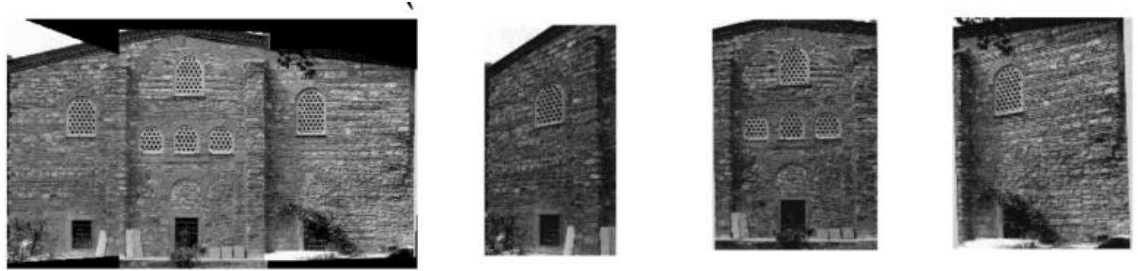
Figure 13: Rectified Image of Mustafa al-Sami's house in Istanbul.

In cases where the facade comprises several adjacent planes or includes shallow protrusions, each plane can be corrected separately and later merged using computer-aided design (CAD) software.

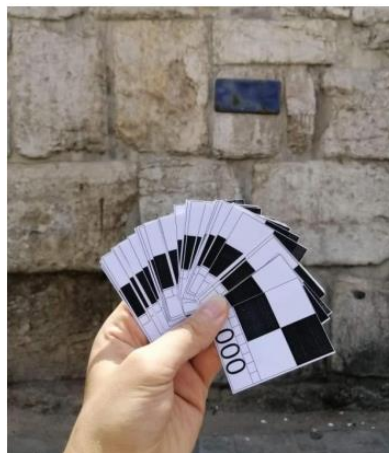
Figure 29: Control Points (markers) example

In photogrammetric documentation, Ground Control Points (GCPs) are indispensable for linking the image-based model to an external spatial reference system. By introducing measured, fixed points into the photogrammetric workflow, geometric distortions are minimized, and the resulting model can be scaled, oriented, and georeferenced with a high degree of accuracy.

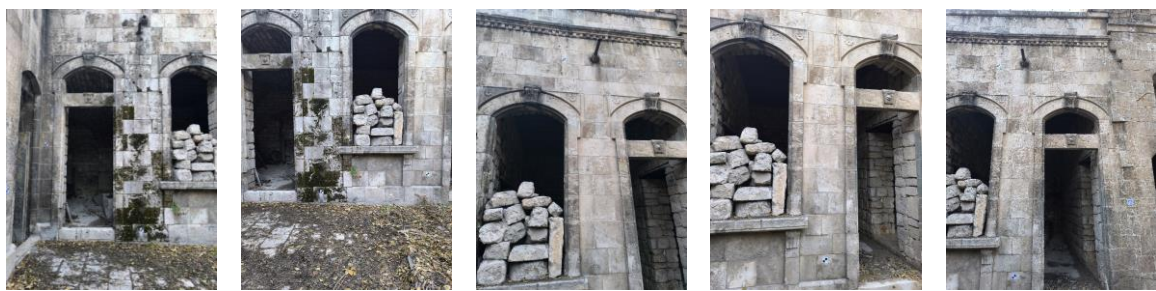
Figure 31: Example of capturing sequence - Yard West Facade - Al- Takiyye

- **Camera orientation:** Photographs must generally be taken with the optical axis perpendicular to the surface and the camera body parallel to the plane being documented, in order to minimize geometric distortion.
- **Redundancy and overlap:** Consecutive images should maintain a minimum overlap of 60–80% in both horizontal and vertical directions, ensuring robust image alignment and sufficient redundancy for bundle adjustment.

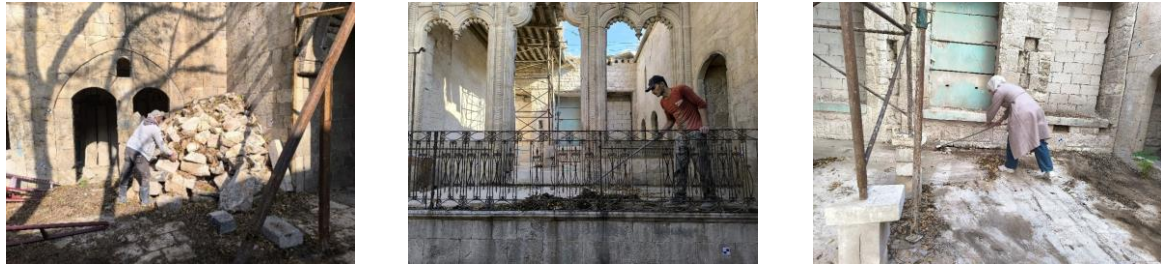
Figure 54: Site cleaning and debris removal – Al-Takiyye

Further obstructions included vegetation growth along the courtyard walls, which concealed architectural details, and a fallen tree trunk in the center of the courtyard. Vegetation was selectively cleared to reveal the underlying masonry, and the trunk was removed to improve accessibility and allow for unobstructed photography.

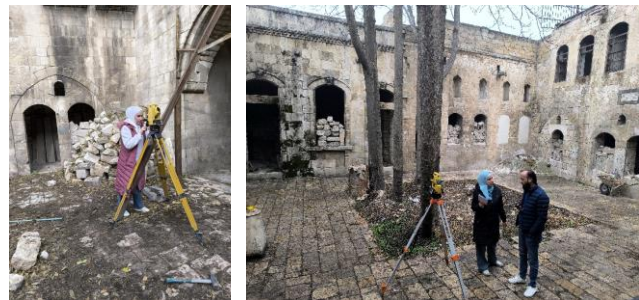
Figure 67: Surveying Coords of Markers

After the placement of the GCPs, their coordinates were measured and recorded using the surveying instrument, with the data stored for subsequent use during the processing stage.

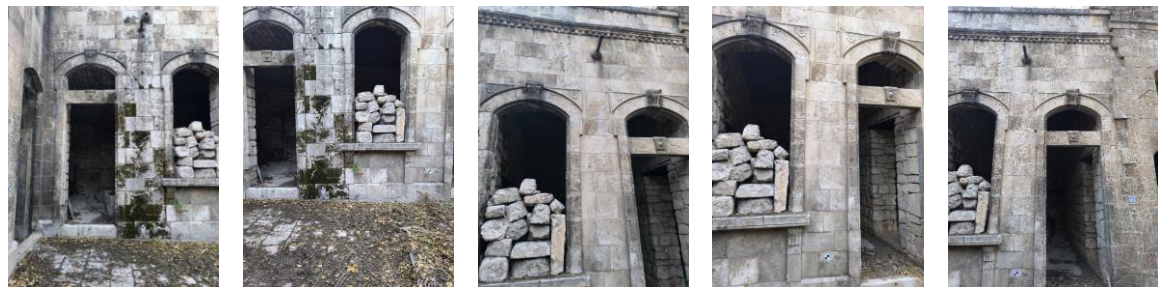
Figure 68: Example of capturing sequence - Yard West Facade - Al- Takiyye

During the photographic acquisition process, detailed field notes were taken to record lighting conditions, environmental factors, and any access-related challenges. Sketches and diagrams were prepared to illustrate the image acquisition layout, and essential metadata—including camera settings, focal length, aperture, and ISO—was systematically documented. In addition, field-based data validation was carried out to ensure dataset quality. This involved preliminary checks of image sharpness, exposure, and overlap; capturing redundant photographs to compensate for potential errors; and creating secure backups and archives of the raw image data.

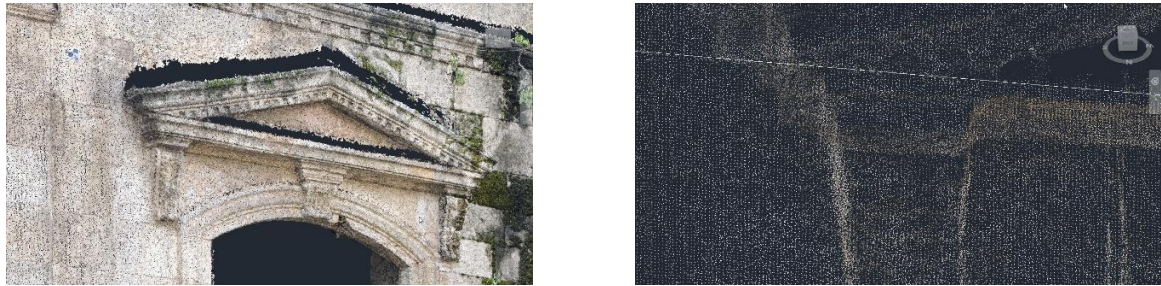
Cloud scattering during zoom-in: This occurs because the point cloud ultimately

consists of a vast number of discrete adjacent points that collectively form the general shape of the building when viewed from a distance. At closer scales, the gaps between points become more visible, leading to a scattered appearance. Moreover, generating continuous mesh surfaces directly from the point cloud is generally impractical, as it would result in an excessively large file, making the model difficult—or even impossible—to process and manage efficiently.

Figure 120: e.g. View of an ornament when zoomed in / out

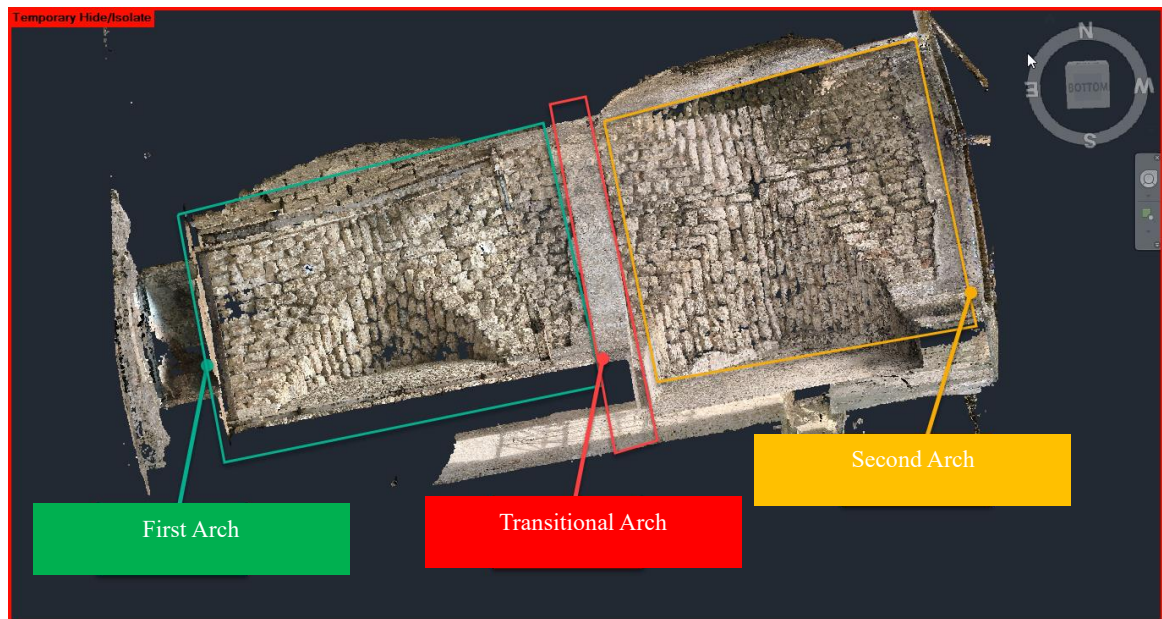
Figure 130: Arches Analysis of Reception Ceiling Main Arch

The **main arch** is composed of four sections, distributed as follows:

- **First arch:** Comprising two sections, extending from the beginning of the entrance to the transitional arch.
- **Transitional arch:** Connects the two main arches and is itself divided into two sections—the first extending from the end of the first arch, and the second beginning at the start of the second arch.
- **Second arch:** Completes the composition of the two main arches and extends from the end of the transitional arch to the termination of the entrance.

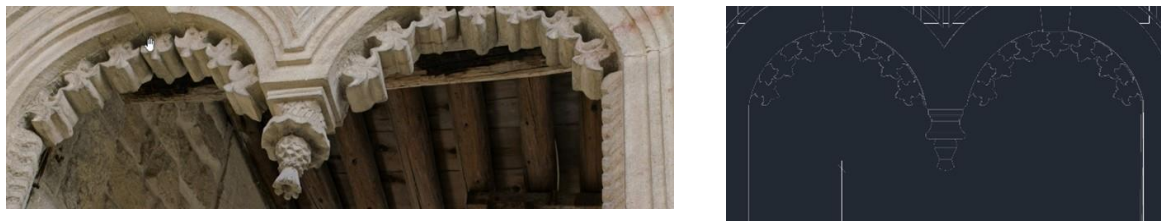
The ornament elements were created using the *Model-In-Place* tool, categorized under **Generic Model**. The ornaments were divided into two types:

Modelable Ornaments: These were modeled to closely reflect reality, using the *Model-In-Place* tools.

Figure 134: Modelable Ornaments

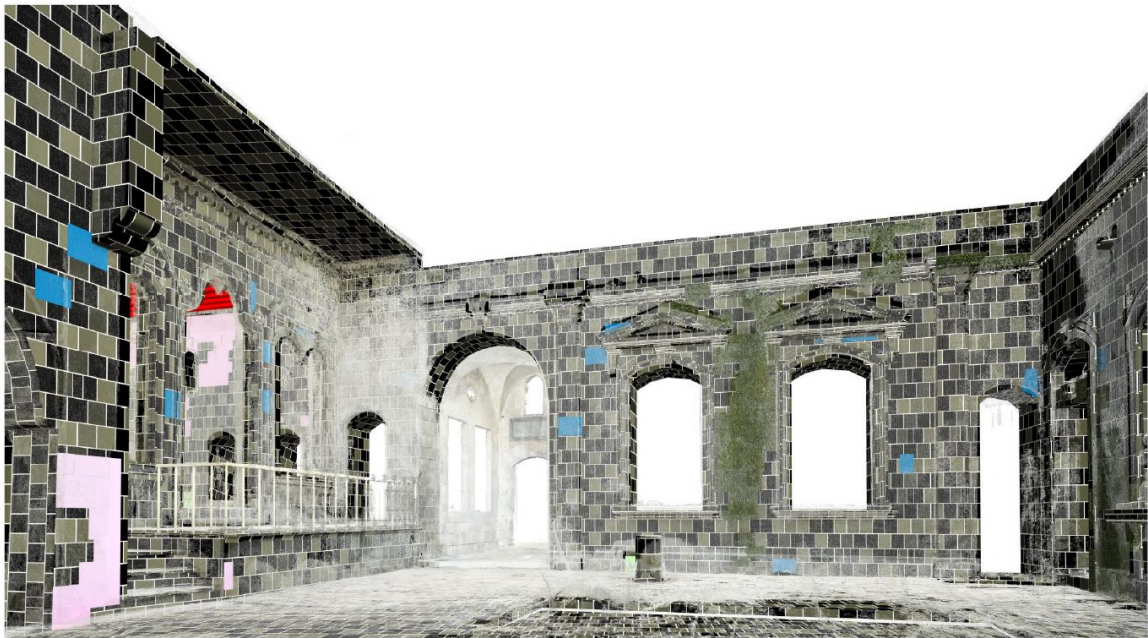
Figure 153: HBIM Model from Composite Point Cloud-CAD, Al-Takiyya (1)

- Achieves greater realism, bringing the model closer to actual site conditions.
- Highlights differences between the theoretical model and the actual building.
- Facilitates easier verification and validation of the model.
- Offers a visually rich presentation that combines realistic visualization with engineering information.
- Enhances support for future maintenance, rehabilitation, and improvement operations.

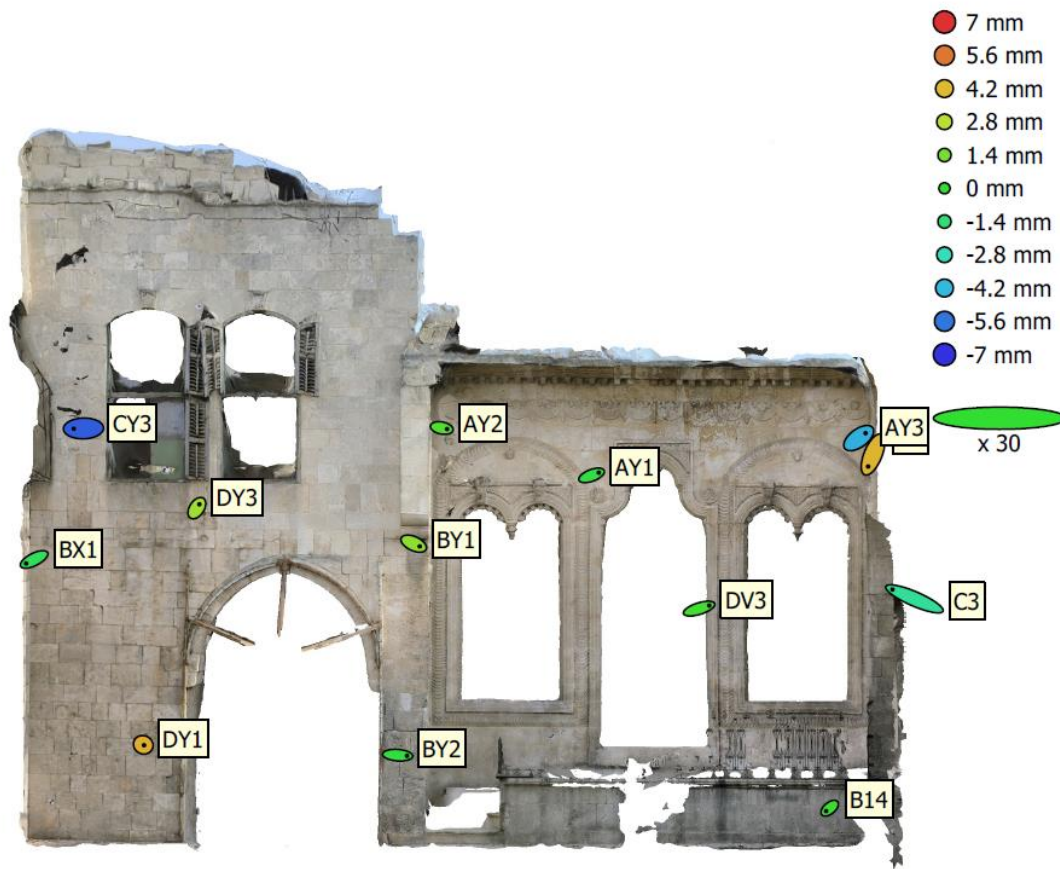
Figure 156: GCPs errors, Eastern Façade, Al-Takiyya

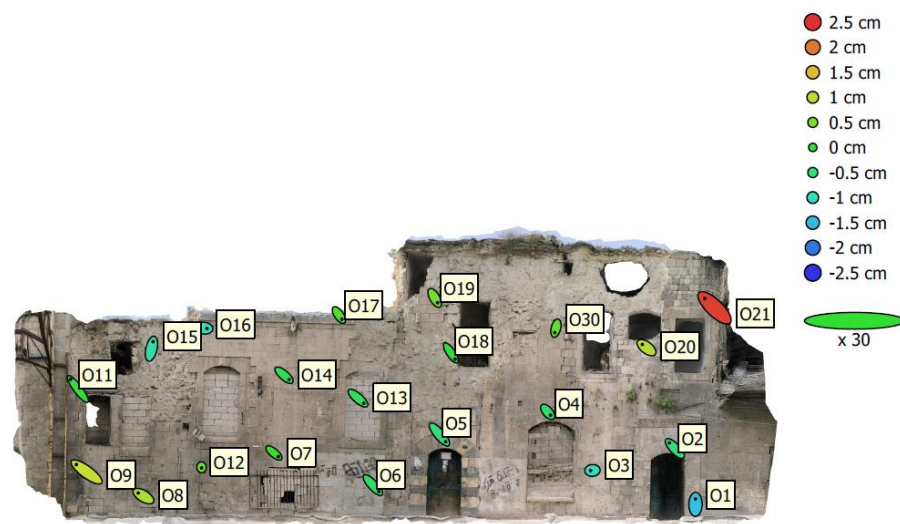
Figure 158: GCPs errors, Exterior Facade, Al-Takiyya

Z error is represented by ellipse color. X,Y errors are represented by ellipse shape. Estimated GCP locations are marked with a dot or crossing.

Point Name	dX Photo (m)	dY Photo (m)	dZ Photo (m)	2D Err Photo (m)	Vert Err Photo (m)	3D Err Photo (m)	Pass/Fail Photo
O9	-0.021	0.016	0.011	0.026	0.011	0.029	FAIL
O8	-0.011	0.006	0.009	0.013	0.009	0.015	PASS
O11	-0.015	0.020	-0.001	0.025	0.001	0.025	FAIL
O16	0.006	-0.001	-0.010	0.006	0.010	0.012	PASS
O12	0.000	-0.001	0.004	0.001	0.004	0.004	PASS
O7	0.009	-0.008	0.000	0.012	0.000	0.012	PASS
O14	0.011	-0.009	-0.003	0.014	0.003	0.014	PASS
O13	0.012	-0.011	-0.003	0.016	0.003	0.016	PASS
O17	0.006	-0.009	0.002	0.011	0.002	0.011	PASS
O6	0.012	-0.013	-0.003	0.018	0.003	0.019	PASS
O19	0.006	-0.010	0.005	0.012	0.005	0.013	PASS
O5	0.013	-0.015	-0.005	0.020	0.005	0.021	FAIL
O1	0.000	0.011	-0.015	0.011	0.015	0.018	PASS
O2	-0.011	0.012	-0.005	0.016	0.005	0.017	PASS
O3	-0.004	0.000	-0.010	0.004	0.010	0.011	PASS
O4	0.006	-0.007	-0.004	0.009	0.004	0.010	PASS
O21	-0.020	0.020	0.024	0.028	0.024	0.037	FAIL
O20	-0.009	0.007	0.010	0.011	0.010	0.015	PASS

Metric	Photogrammetry
Max 2D error (m)	0.028264
Mean 2D error (m)	0.014025
Max vertical error (m)	0.024030
Mean vertical error (m)	0.006469
Max 3D error (m)	0.037099
Mean 3D error (m)	0.016272
PASS count	17
FAIL count	4
RMSE 3D	0.017736

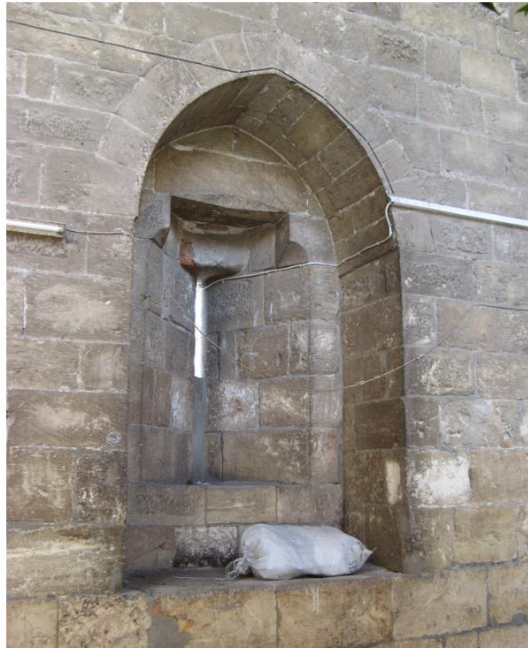
The architectural features of the mosque suggest that it was constructed near the city limits, though still within the defensive walls. The evidence lies in the fact that the eastern wall of the mosque coincides with the city wall itself, and this wall is markedly more solid in its design than the other external walls of the structure. A construction inscription embedded in this wall, dated Jumada al-Thani 903 / January–February 1491, records the building of the city wall during the reign of the Mamluk Sultan al-Malik al-Nasir Abu al-Sa‘adat Muhammad (r. 901–904/1496–1498), son of Sultan al-Malik al-Ashraf Qaytbay. The works were commissioned by the governor of Aleppo, Janbulat, and carried out under the supervision of Sayf al-Din Misrbay, governor of the Aleppo Citadel. This wall also incorporates a niche containing an arrow-slit, further attesting to its defensive character. Moreover, the mosque’s integration into the city wall is corroborated by Ibn al-

Figure 166: The eastern wall of the mosque: a niche with an arrow-hole

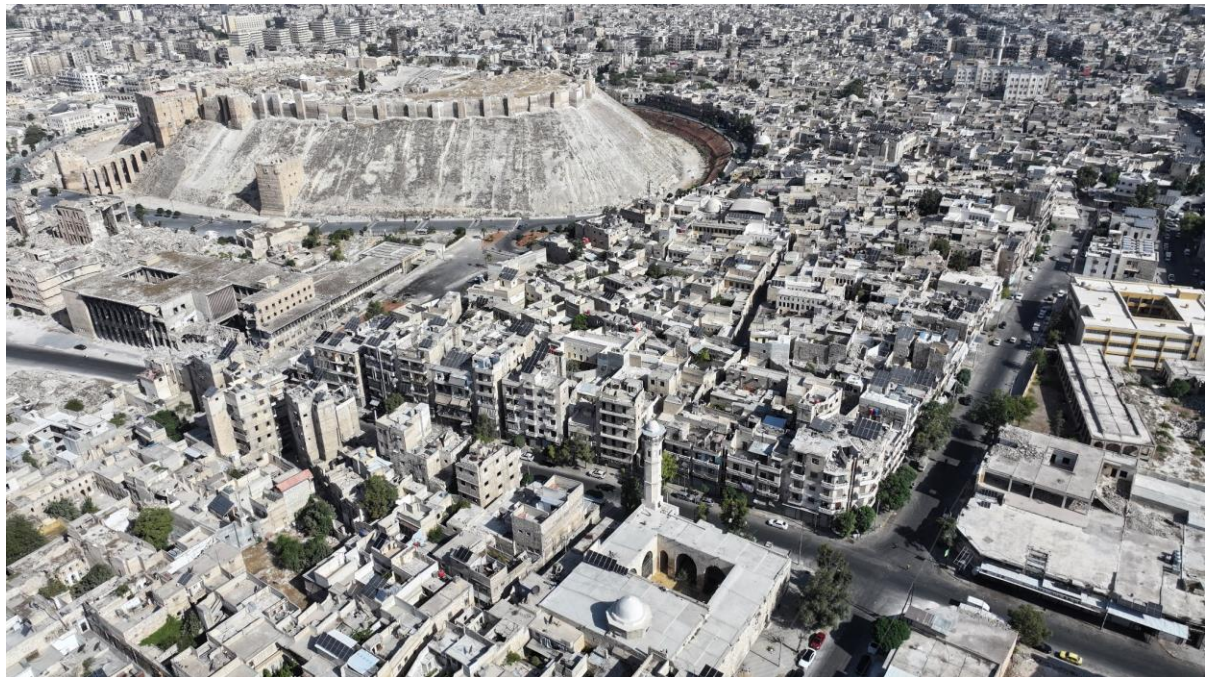
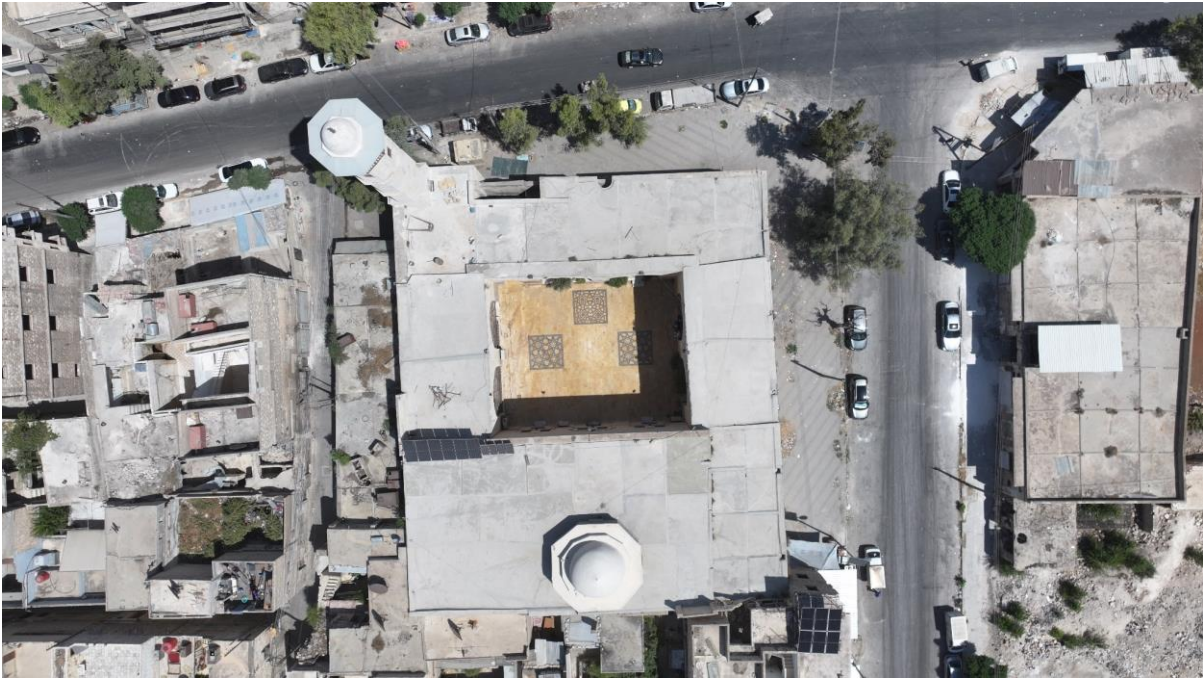
Figure 182: Aerial Image of Al-Tunbugha Mosque

The use of a drone proved essential for documenting areas that were otherwise inaccessible, such as the rooftop, external dome, and the upper sections of the minaret. By enabling video capture at elevated heights, the drone eliminated the need for scaffolding or vantage points from nearby buildings, which would have compromised both safety and image quality. The aerial dataset not only provided comprehensive coverage of vertical and curved surfaces but also enriched the photogrammetric model with details that would have been impossible to obtain from ground-based photography alone.

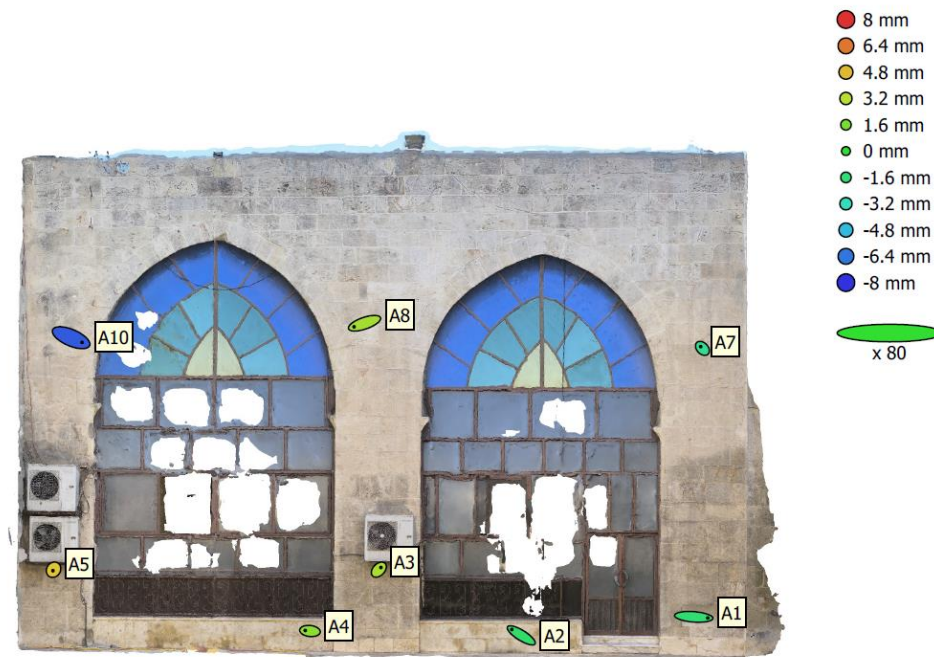
Figure 247: GCPs errors, Western Façade, Al-Tunbugha

Z error is represented by ellipse color. X,Y errors are represented by ellipse shape. Estimated GCP locations are marked with a dot or crossing.

Point Name	dX Photo (m)	dY Photo (m)	dZ Photo (m)	2D Err Photo (m)	Vert Err Photo (m)	3D Err Photo (m)	Pass/Fail Photo
A3	0.001	0.001	0.003	0.002	0.003	0.003	PASS
A4	-0.002	0.000	0.002	0.002	0.002	0.003	PASS
A8	-0.005	-0.002	0.003	0.006	0.003	0.006	PASS
A10	0.006	-0.002	-0.007	0.006	0.007	0.009	PASS
A5	0.000	0.000	0.005	0.001	0.005	0.005	PASS
A7	-0.001	0.001	-0.002	0.001	0.002	0.003	PASS
A2	-0.005	0.003	-0.001	0.006	0.001	0.006	PASS
A1	0.007	-0.001	-0.001	0.007	0.001	0.007	PASS

PASS count	8
FAIL count	0
RMSE 3D	0.005743

These results suggest that façade orientation and imaging conditions played a role in lowering positional accuracy. Western façades often suffer from strong contrasts and shadowing during image capture, which can reduce tie-point quality and weaken photogrammetric solutions. Additionally, architectural irregularities or occlusions may have contributed to higher local errors.

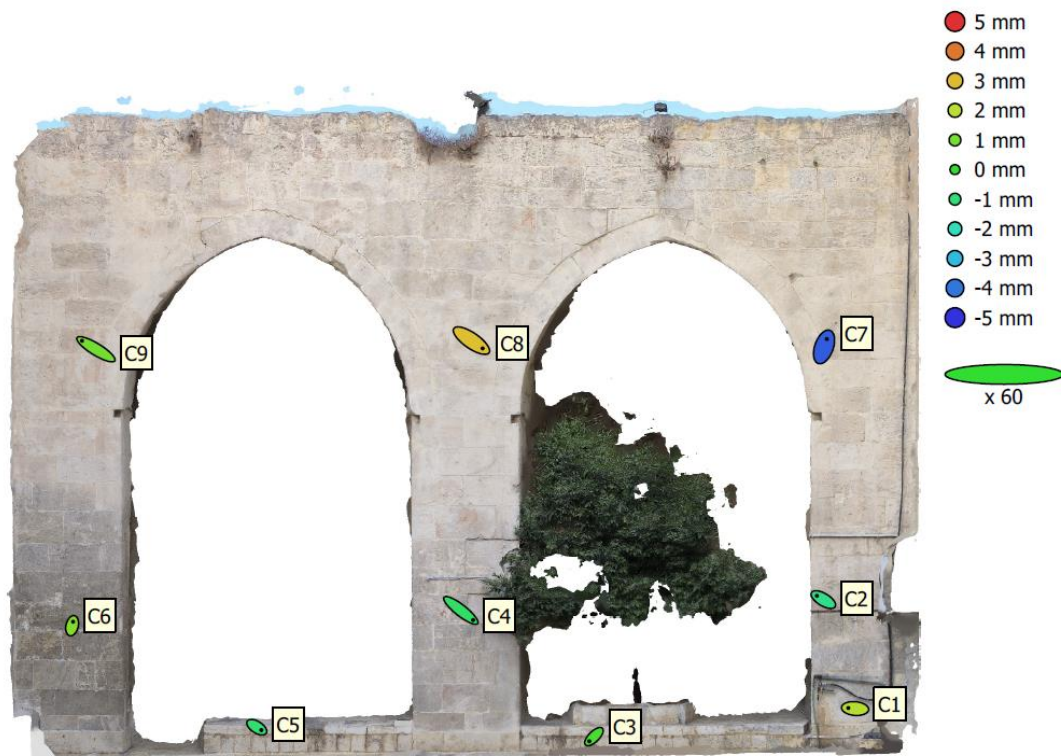
Figure 249: GCPs errors, Eastern Façade, Al-Tunbugha

Z error is represented by ellipse color. X,Y errors are represented by ellipse shape. Estimated GCP locations are marked with a dot or crossing.

The Eastern Façade achieved excellent positional accuracy, with every GCP falling below the 1 cm tolerance. Planimetric performance was particularly strong (mean 2D error of 0.005 m), while vertical deviations were negligible (mean 0.002 m). The overall 3D RMSE of 0.006 m confirms consistent accuracy across the dataset, with the maximum observed deviation (0.009 m) remaining within acceptable thresholds.

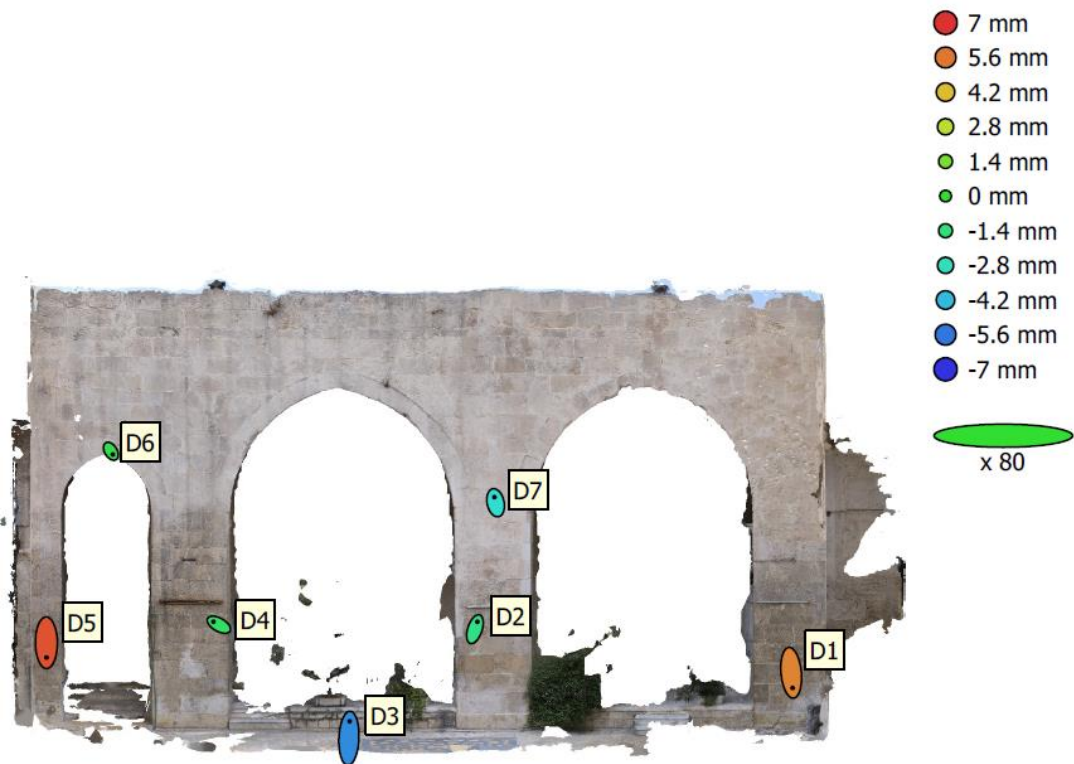
Figure 250: GCPs errors, Northern Façade, Al-Tunbugha

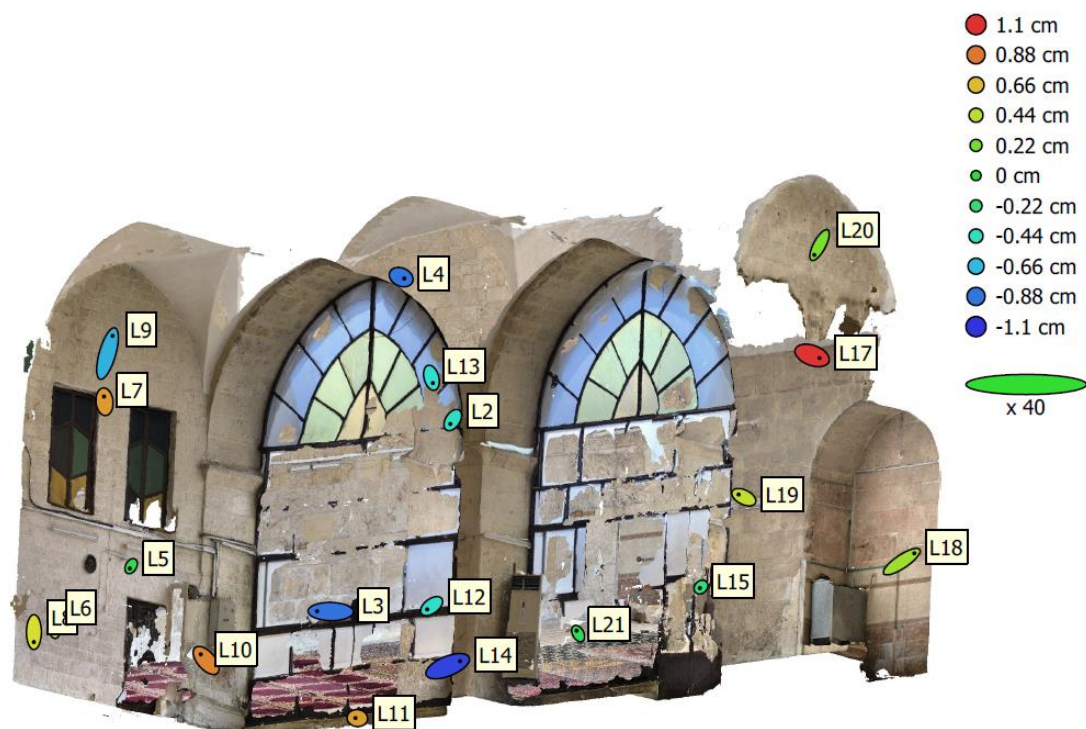
Figure 251: GCPs errors, Al-Higazia, Al-Tunbugha

Z error is represented by ellipse color. X,Y errors are represented by ellipse shape. Estimated GCP locations are marked with a dot or crossing.

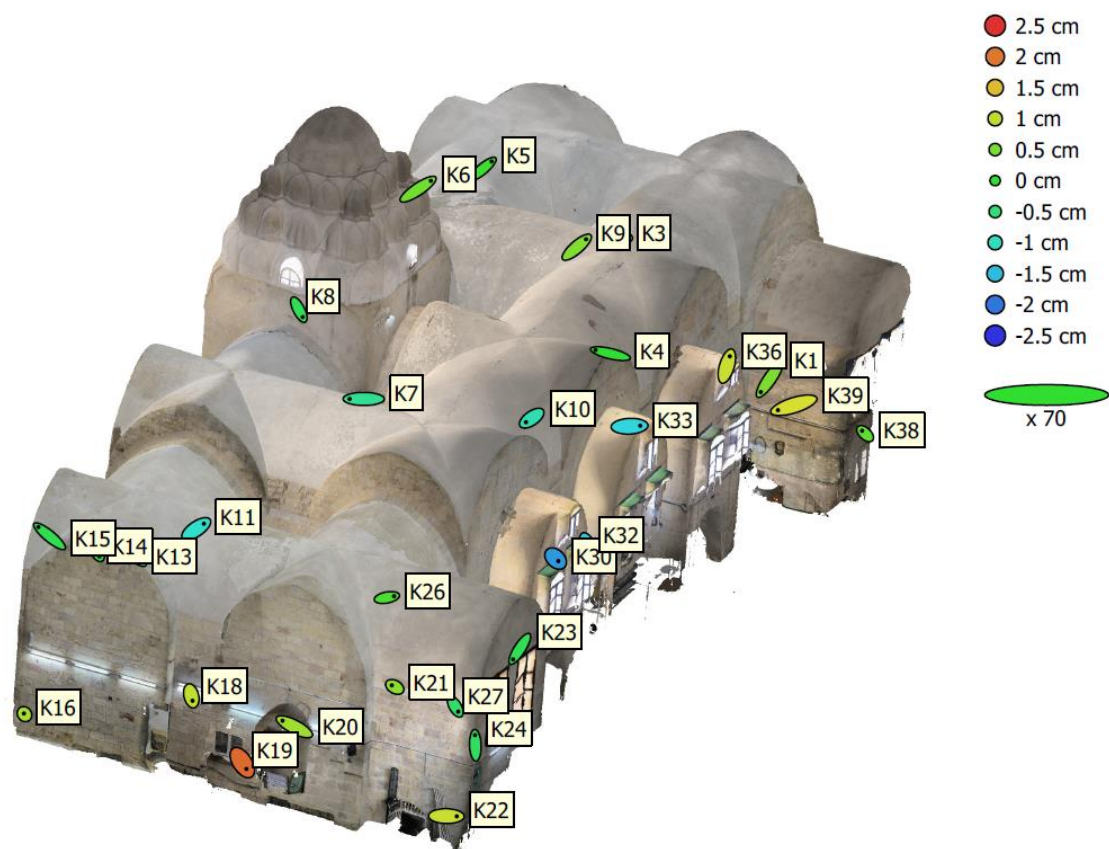
Figure 252: GCPs errors, Al-Qublia, Al-Tunbugha

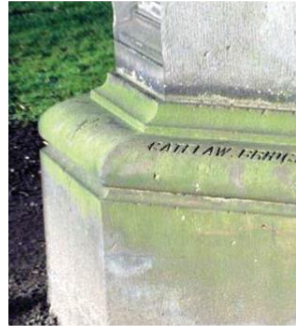
Phenomena	Definition	Example
Alteration تَغْيِير	Modification of the material that does not necessarily imply a worsening of its characteristics from the point of view of conservation. For instance, a reversible coating applied on a stone may be considered as an alteration.

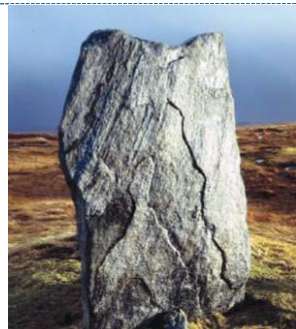
Weathering تَجْوِيَة	Any chemical or mechanical process by which stones exposed to the weather undergo changes in character and deteriorate

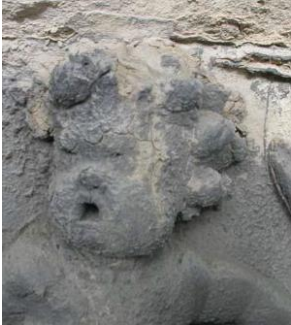
Decay اضمحلال	Any chemical or physical modification of the intrinsic stone properties leading to a loss of value or to the impairment of use.

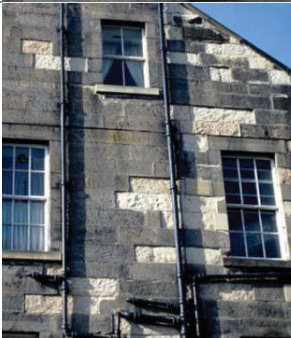
Deterioration تلف	Process of making or becoming worse or lower in quality, value, character, etc...; depreciation.

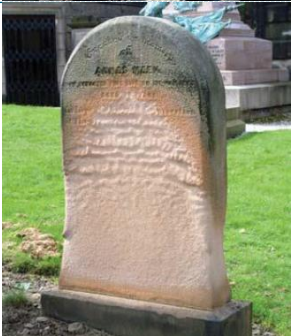
Damage ضرر	Human perception of the loss of value due to decay.
